Emergency  
Services  
Commissioner

# Review of the **TriTech Lubricants factory fire**

19 May 2011

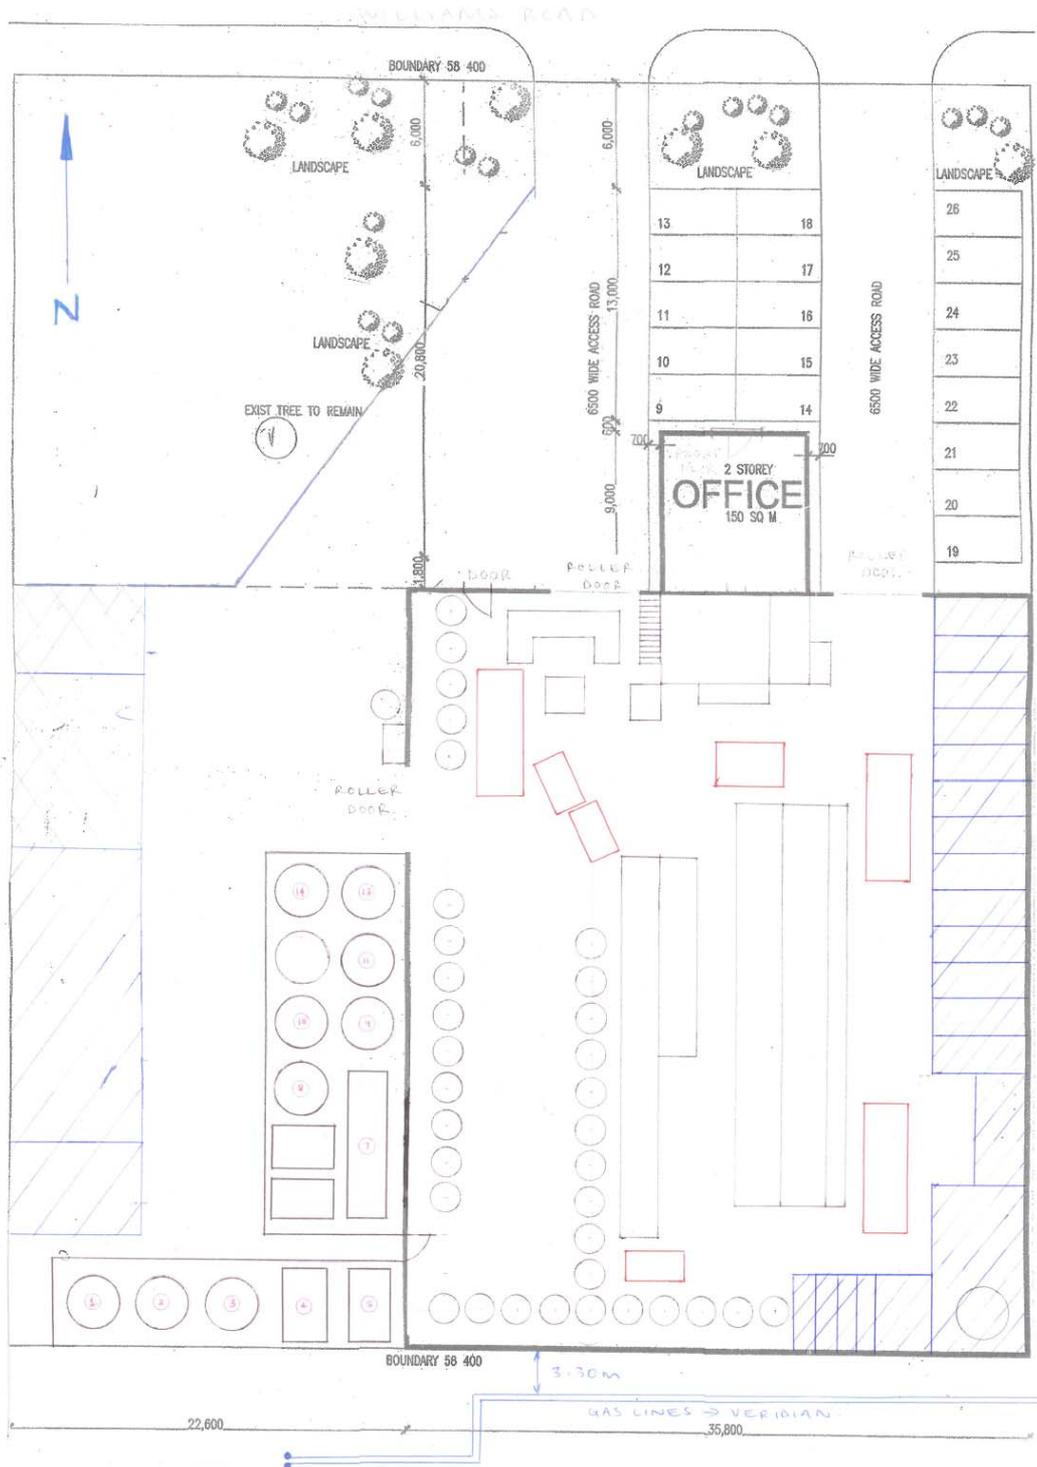
The building was approximately 1,685 square metres (m<sup>2</sup>) in size. It incorporated a two-level office at the front with a floor area of 150 m<sup>2</sup> and a warehouse at the rear with a floor area of 1,535 m<sup>2</sup> (see Figure 1). The building construction comprised horizontal concrete tilt slabs supported by a heavy steel portal frame with a tin clip-lock roof. The building had fire hose reels installed, but not an on-site fire hydrant or fire detection system.

Figure 1. Site and building layout (Source: CFA)

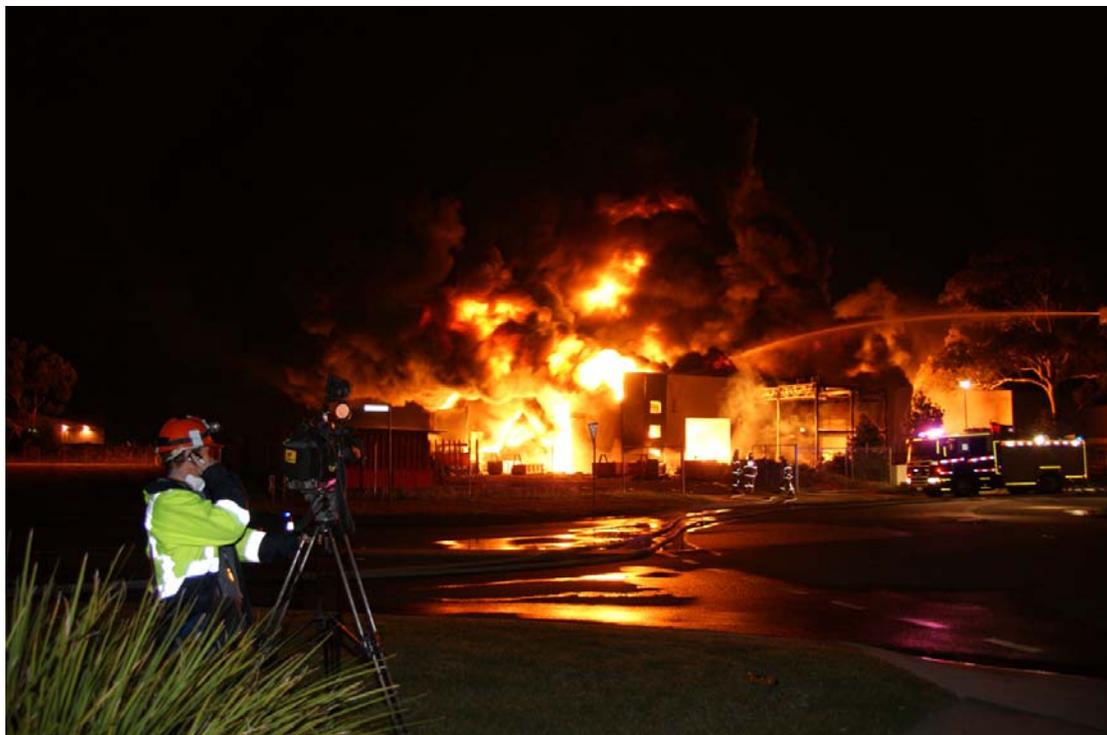
Figure 2. TriTech fire taken at 4.04 am 20 May 2011 (Keith Pakenham, CFA)

The fire spread rapidly through the building and involved plastic containers of product. Uncontained oil spread the fire to the external bulk storage areas. The incident controller requested the dispatch of additional resources, which included a number of fire appliances from the MFB. The rapid development of the fire resulted in a defensive strategy being adopted to protect adjacent buildings and gas pipelines at the rear of the premises. These contained hydrogen (flammable gas), nitrogen (an inert gas) and compressed air.

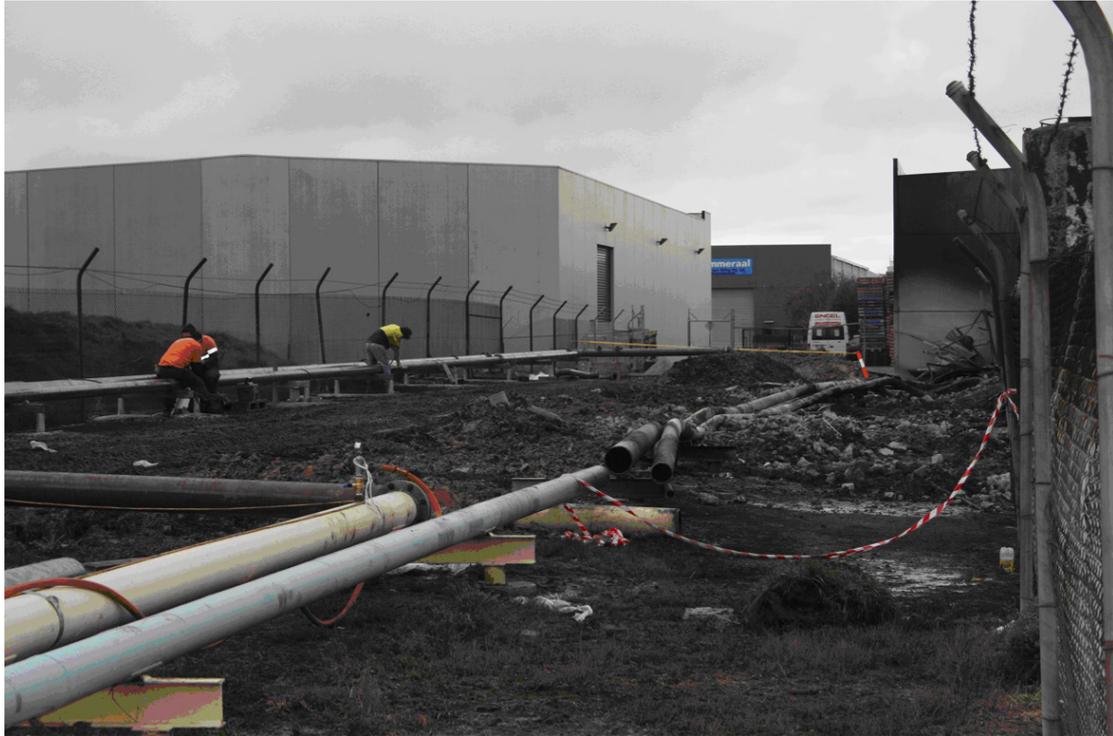
The rear wall of the building collapsed and damaged the nitrogen pipe line, however this did not present a hazard. The gas supplies were later isolated by a BOC representative. Water supplied by hydrants near the factory was insufficient so water was pumped from Greens Road, approximately one kilometre away, by means of a pump relay<sup>4</sup>. Further water was drawn from storage at the neighbouring Viridian glass factory. A large volume of water was used during fire fighting operations to cool the fire sufficiently to enable the application of fire fighting foam, which ultimately extinguished the fire.

**Figure 3. Hydrogen, nitrogen and compressed air pipelines located to the rear of TriTech** (K Pakenham, CFA)

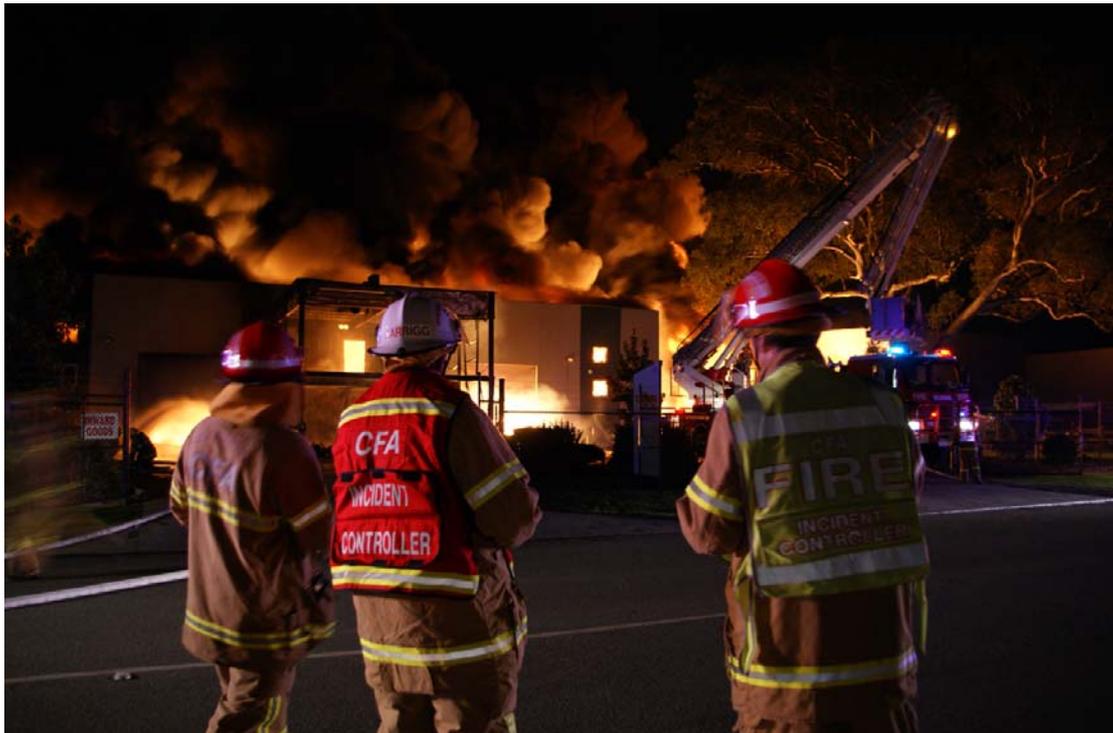
The review team noted that the tabards worn on the fireground to identify the 'incident controller' did not comply with AIIMS and the EMMV. These specify that a white tabard is to be worn. Incident controller tabards worn on the fireground at TriTech were red and lime green. The lime green tabards currently used by CFA are reported to lack visibility when worn with the light-coloured Nomex protective clothing.

Figure 6. Incident controller tabards (note: photograph taken during the handover of incident control 8.55 pm) (Keith Pakenham, CFA)

The colours of incident management tabards worn on the fireground were inconsistent with both AIIMS and the EMMV.

The Fire Services Commissioner ensures that there is a single standard for the tabards worn by the IMT on the fireground and in control centres to ensure consistency and aid interoperability.

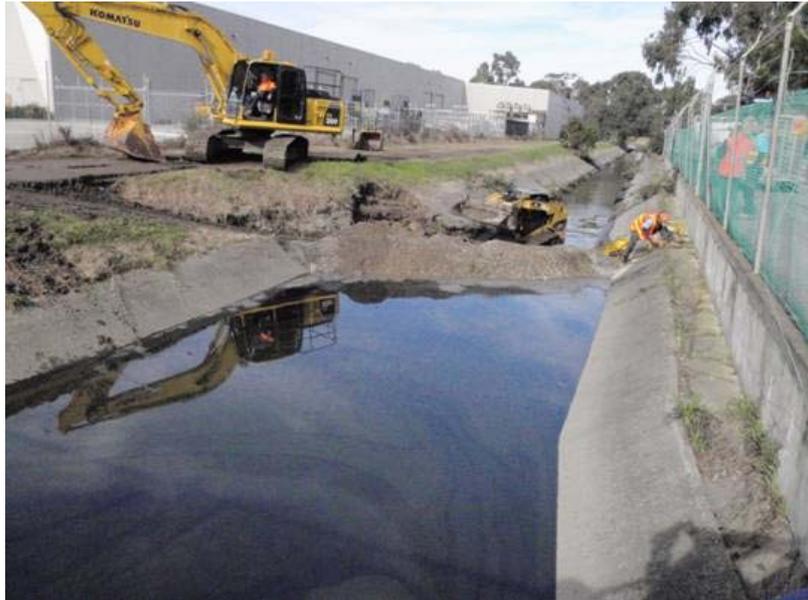
Dandenong City Council arrived on scene at midnight with sand to be used by Melbourne Water to block storm water drains. Oil and water travelled several kilometres in the storm water drains before being contained at Abbots Road and within a short section of natural creek at the end of the Abbots Road drain prior to reaching the Eumemmerring and Dandenong creeks.

**Figure 7. Sand bunding used to contain oil and contaminated water run-off (Source: Melbourne Water)**
