Emergency  
Services  
Commissioner

# Review of the **TriTech Lubricants factory fire**

19 May 2011

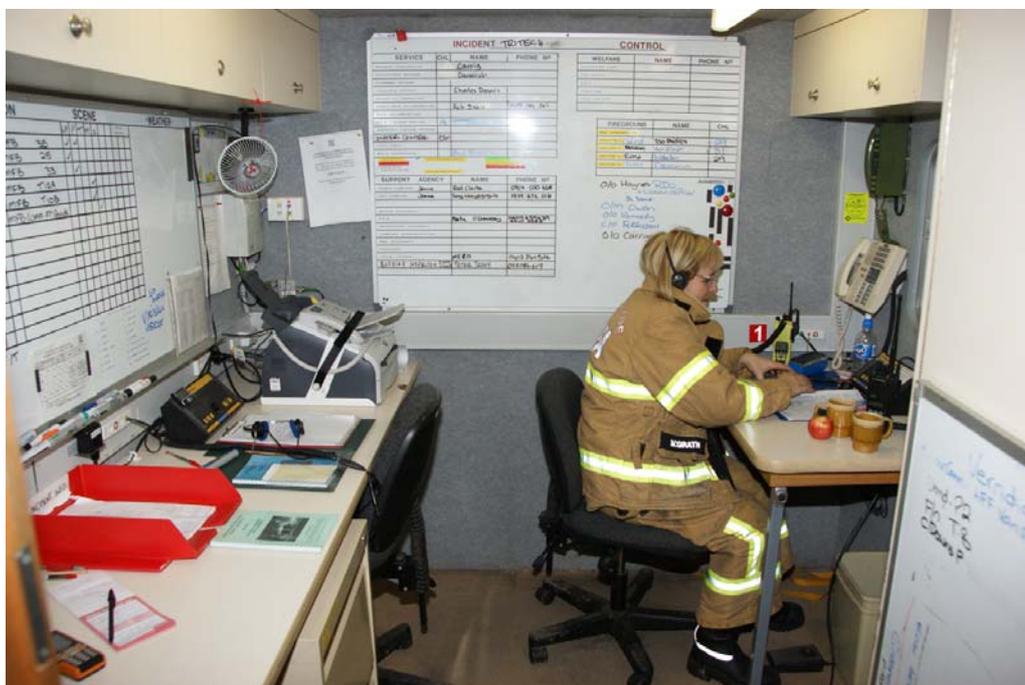
The mobile communications vehicle (MCV) from Patterson River CFA brigade arrived at 9.10 pm and provided on-scene communications. The review team were told that the vehicle was too small to accommodate IMTs and EMTs at complex, large or prolonged incidents.

Figure 5 Mobile communications vehicle (Keith Pakenham, CFA)

The MFB has a well-equipped, state-of-the-art command and control vehicle that provides spacious meeting areas for management teams, including information and media personnel. The review team believes the MFB vehicle should be available for large incidents in fringe areas of CFA jurisdiction.
